SODA SPRINGS AIRPORT (ALLEN H. TIGERT)

This report describes how your pavement maintenance management program was developed. This program was developed as part of the Network Pavement Management Program project sponsored by the Idaho Transportation Department, Division of Aeronautics. The information and data contained in this report ensures you are in compliance with the requirements of Federal Aviation Administration (FAA) Grant Assurance Number 11 which states that any airport requesting federal funds for pavement improvement projects must have implemented a pavement maintenance management program (PMMP).

Using the branch, section and sample unit divisions established, a visual condition survey was conducted at Soda Springs Airport (Allen H. Tigert) on November 05, 2006. During the inspection pavement defects were identified and measured in accordance with the methodology outlined in FAA AC:150/5380-6 and ASTM D5430. Our inspection ensures your airport complies with the “detailed inspection” requirement of FAA’s PMMP guidelines. After collection, the data were entered into the Micro PAVER software for analysis. These data are reproduced in the Re-Inspection Report attached in

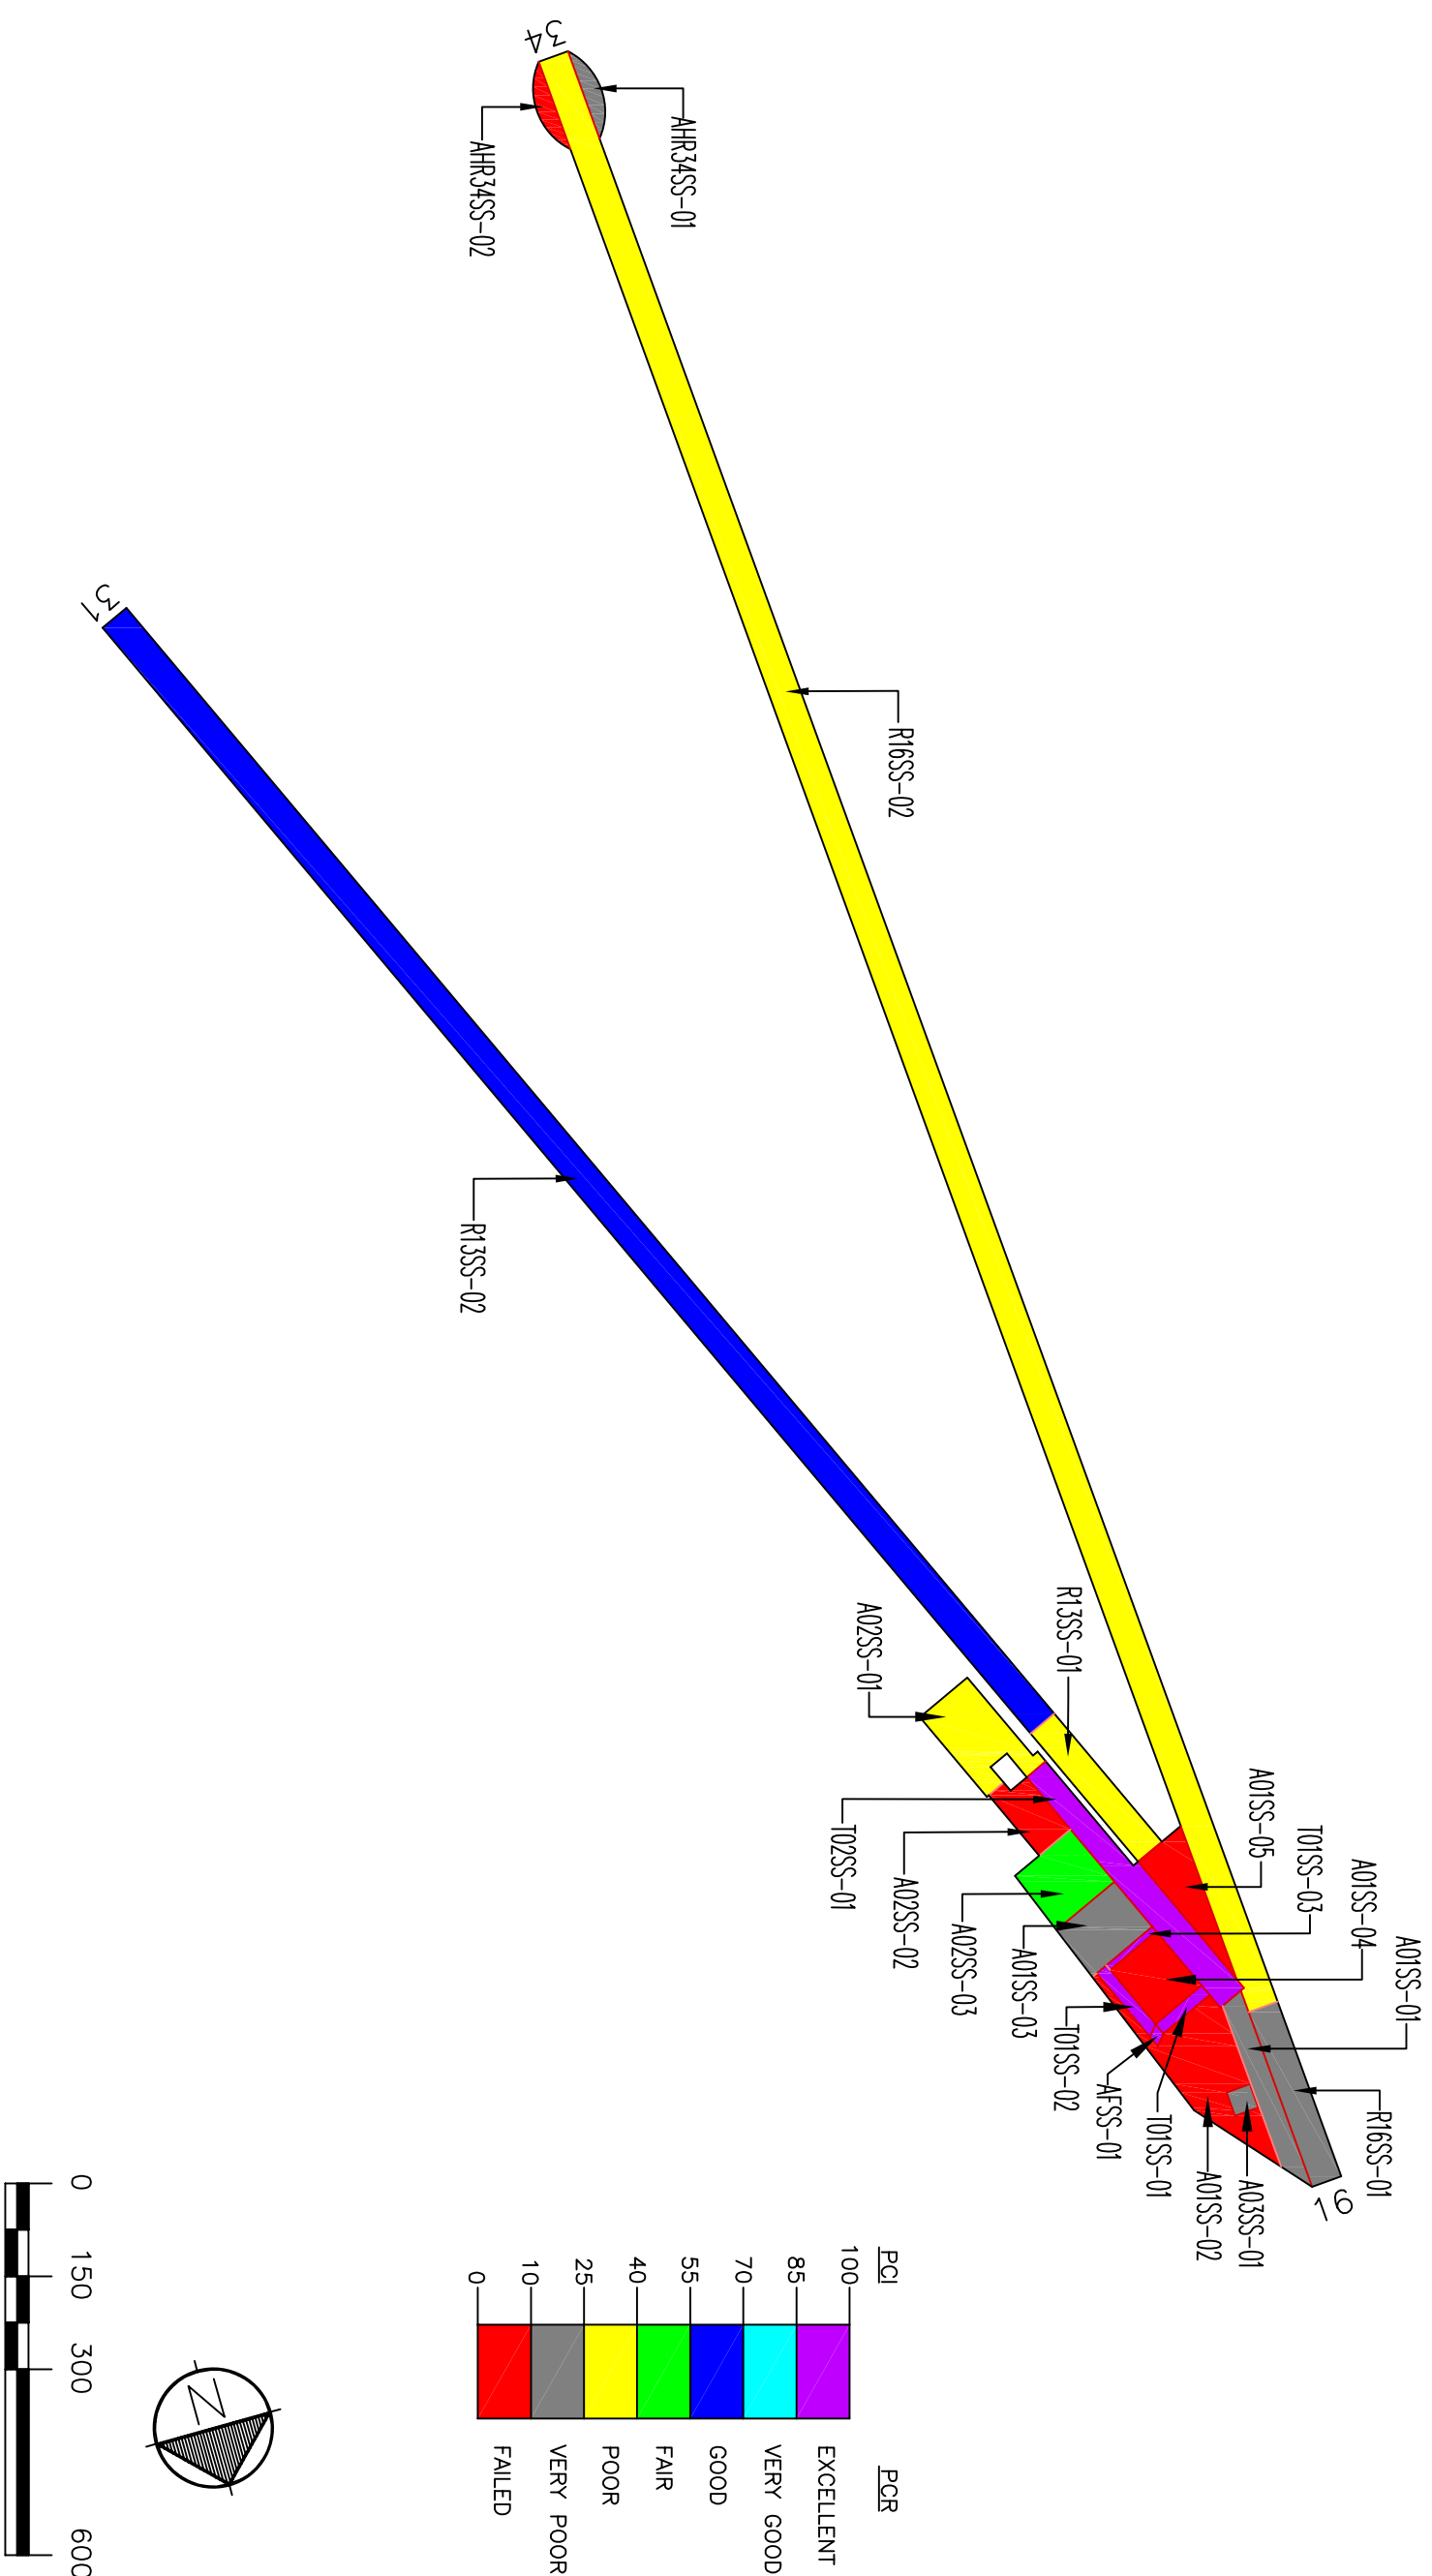
Figure SS-3. Pavement Condition in 2006.
Soda Springs Airport (Allen H. Tigert)

Using the data collected during the visual inspection, the Micro PAVER software calculated a Pavement Condition Index (PCI) for each pavement section inspected by averaging the PCIs for inspected sample units. Using each section’s PCI, a Pavement Condition Rating (PCR) was assigned. The PCIs and associated PCRs from this inspection are shown in Table SS-2. This table also contains projected PCIs for 2011 and 2016 based on pavement deterioration models developed by Micro PAVER using the inspection data from pavements in Idaho having the same surface types. The Branch Condition Report in Appendix 2 summarizes current pavement condition by branch while the Section Condition Report in Appendix 2 lists pavement condition by section. The current PCR is shown graphically in Figure SS-3.

Section PCIs at the airport range from a low of 1 (a PCR of “Failed”) to a high of 100 (a PCR of “Excellent”). The area-weighted average PCI for all airport pavements is 41, corresponding to an overall PCR of “Fair”. Figure SS-4 shows how much pavement area is associated with each Pavement Condition Rating category and also shows pavement condition distribution from the inspections conducted in 1996 and 1999. A graphical representation of the projected PCRs presented in Table SS-2 is shown in Figure SS-5.

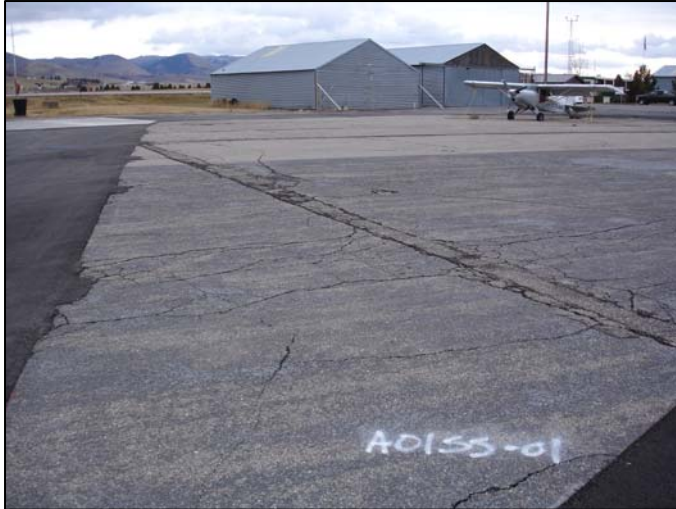
Sample Number: 01	Type: R	Area:	1,094.00SqFt	PCI = 18
41 ALLIGATOR CRACKING		M	300.00 SqFt	
45 DEPRESSION		L	10.00 SqFt	
43 BLOCK CRACKING		M	793.98 SqFt

Sample Number: 02	Type: R	Area:	5,400.00SqFt	PCI = 21
41 ALLIGATOR CRACKING		M	1,199.99 SqFt	
43 BLOCK CRACKING		M	4,199.94 SqFt

Sample Number: 03	Type: R	Area:	4,544.00SqFt	PCI = 1
41 ALLIGATOR CRACKING		M	550.00 SqFt	
43 BLOCK CRACKING		M	3,493.94 SqFt	
41 ALLIGATOR CRACKING		H	500.00 SqFt	
52 WEATHERING/RAVELING		H	300.00 SqFt

Section: A01SS-01
Block Cracking
Alligator Cracking

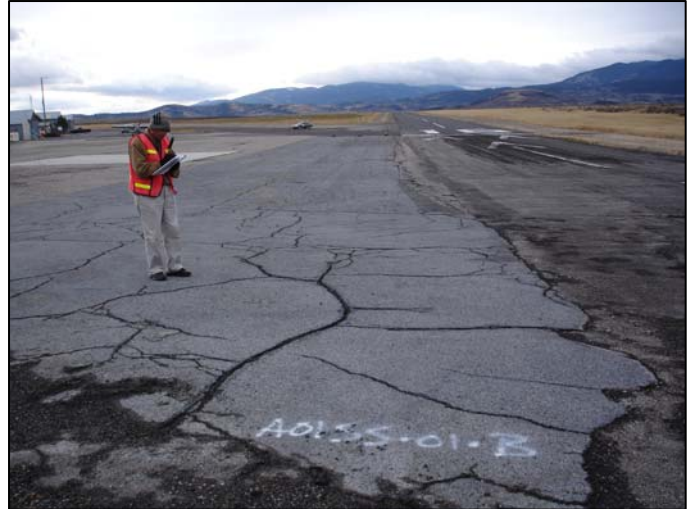
Sample Number: 01 Type: R Area: 1,643.00SqFt PCI = 0
41 ALLIGATOR CRACKING M 500.00 SqFt
41 ALLIGATOR CRACKING H 485.00 SqFt
52 WEATHERING/RAVELING M 657.98 SqFt

Sample Number: 02 Type: R Area: 5,000.00SqFt PCI = 5
41 ALLIGATOR CRACKING M 1,499.99 SqFt
41 ALLIGATOR CRACKING H 500.00 SqFt
52 WEATHERING/RAVELING M 999.99 SqFt

Sample Number: 03 Type: R Area: 5,000.00SqFt PCI = 3
41 ALLIGATOR CRACKING M 3,499.97 SqFt
41 ALLIGATOR CRACKING H 400.00 SqFt
43 BLOCK CRACKING M 1,099.99 SqFt

Sample Number: 05 Type: R Area: 4,603.00SqFt PCI = 0
41 ALLIGATOR CRACKING M 500.00 SqFt
41 ALLIGATOR CRACKING H 1,999.98 SqFt
43 BLOCK CRACKING M 999.99 SqFt

Section: A01SS-02
Block Cracking

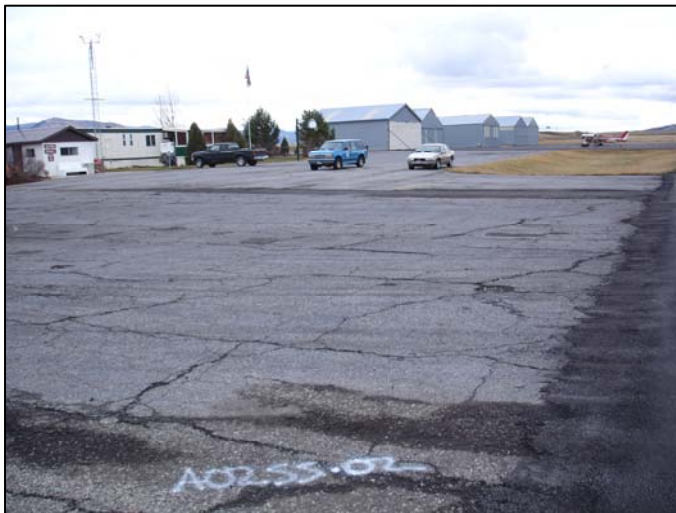
Sample Number:	01	Type:	R	Area:	4,504.00SqFt	PCI = 6
41	ALLIGATOR CRACKING			M	999.99 SqFt	
41	ALLIGATOR CRACKING			H	252.00 SqFt	
43	BLOCK CRACKING			L	1,899.98 SqFt	
43	BLOCK CRACKING			H	300.00 SqFt

Sample Number:	02	Type:	R	Area:	3,300.00SqFt	PCI = 1
41	ALLIGATOR CRACKING			L	500.00 SqFt	
41	ALLIGATOR CRACKING			M	999.99 SqFt	
41	ALLIGATOR CRACKING			H	150.00 SqFt	
43	BLOCK CRACKING			L	999.99 SqFt	
43	BLOCK CRACKING			H	649.99 SqFt	
50	PATCHING			L	180.00 SqFt

Section: A02SS-02
Block Cracking
Alligator Cracking

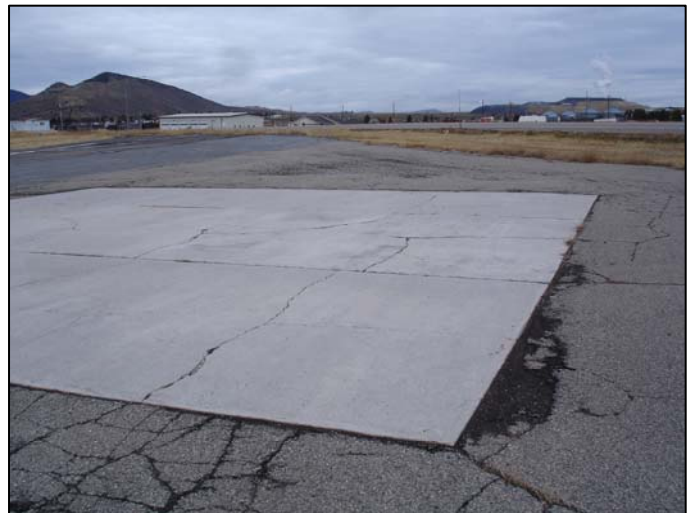
Sample Number:	01	Type:	R	Area:	6.00Count	PCI = 11
65	JOINT SEAL DAMAGE			H	6.00 Count	
72	SHATTERED SLAB			M	6.00 Count

Section: A03SS-01
Shattered Slab
Joint Seal Damage

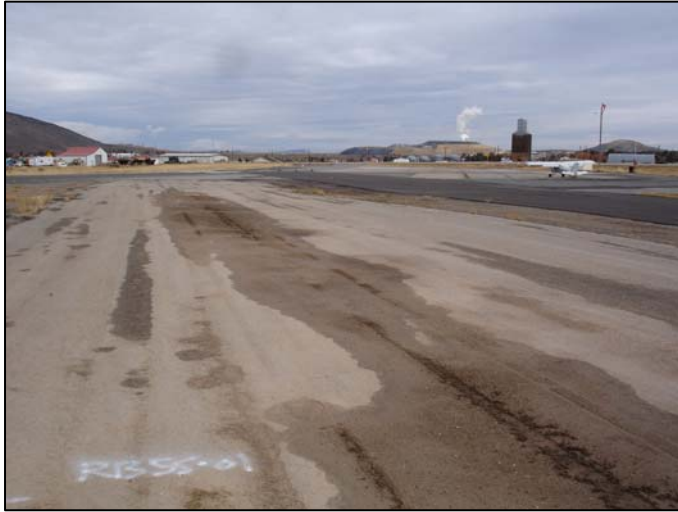
Section: R13SS-01
Weathering/ Raveling

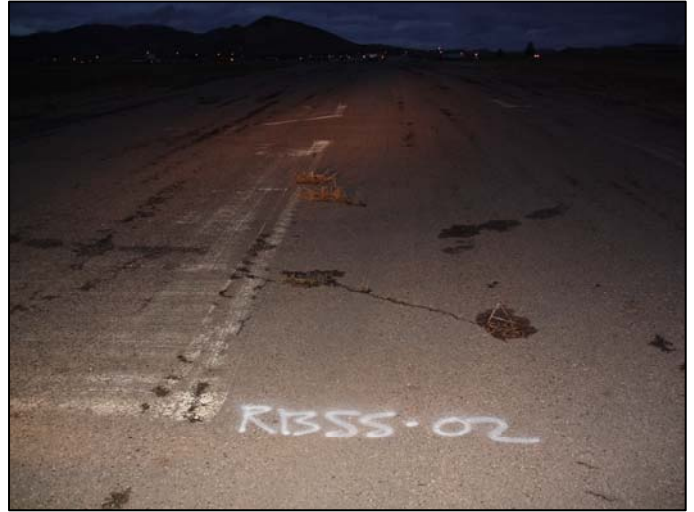
Section: R13SS-02
Weathering/ Raveling

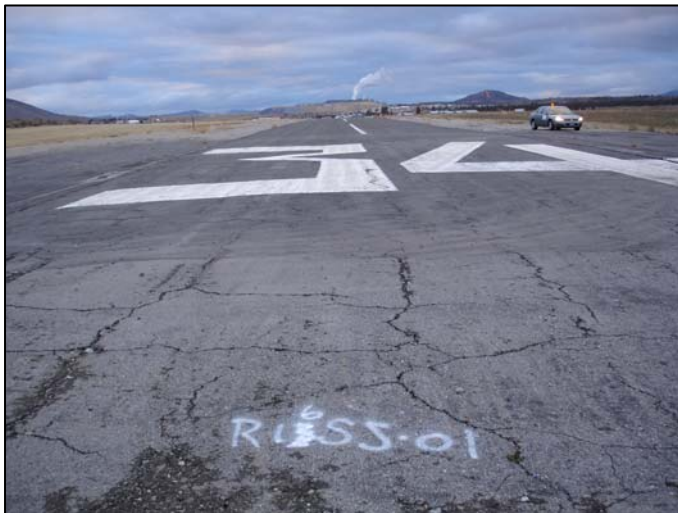
Section: R16SS-01
Block Cracking
Weathering/ Raveling

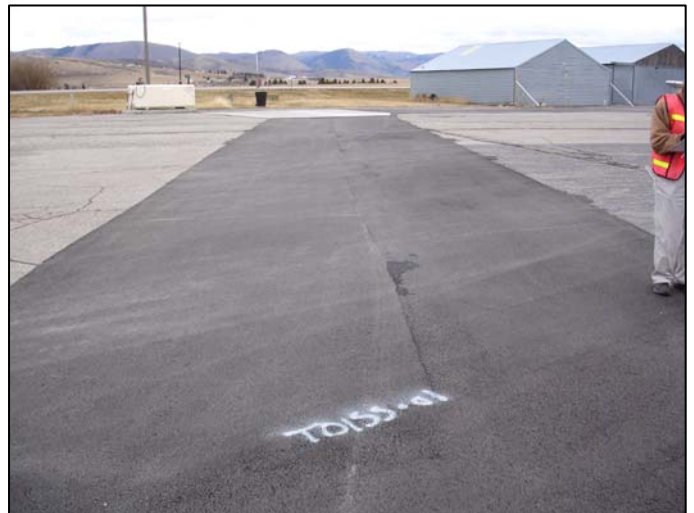
Section: T01SS-01
No Distress

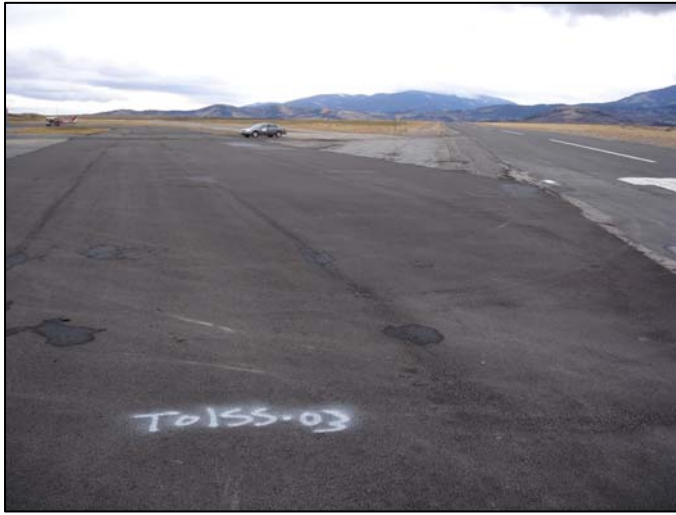
Section: T01SS-03
No Distress

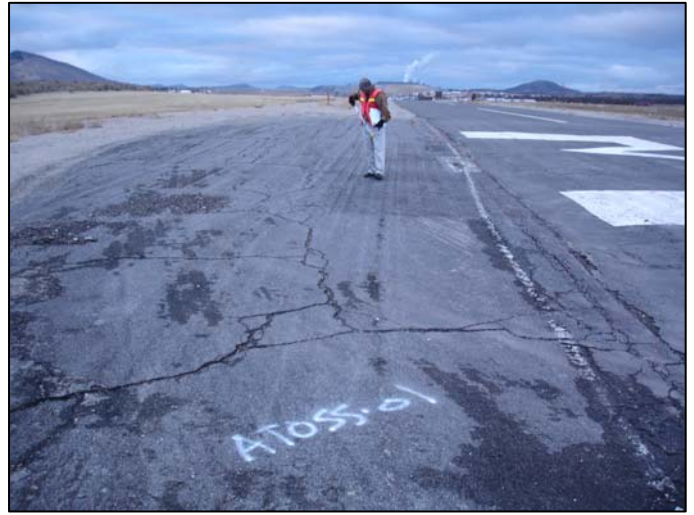
Sample Number:	01	Type:	R	Area:	3,094.00SqFt	PCI = 24
43	BLOCK CRACKING			M	1,546.99 SqFt	
43	BLOCK CRACKING			H	1,546.99 SqFt	
52	WEATHERING/RAVELING			M	200.00 SqFt

Section: AHR34SS-01
Block Cracking

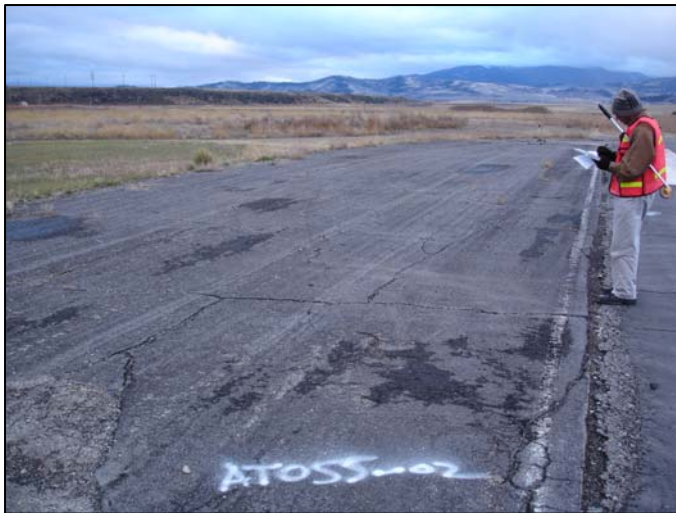
Sample Number:	01	Type:	R	Area:	3,094.00SqFt	PCI = 7
41	ALLIGATOR CRACKING	M		242.00	SqFt	
43	BLOCK CRACKING	M		1,546.99	SqFt	
43	BLOCK CRACKING	H		1,546.98	SqFt	
52	WEATHERING/RAVELING	M		576.00	SqFt

Section: AHR34SS-02
Block Cracking
